# Lafayette and Vermilion Parishes Major Coulees and Vermilion River

Flood Mitigation Project

# Risk Analysis of Major Coulees Ile des Cannes Mine

Impact on Vermilion River Levels

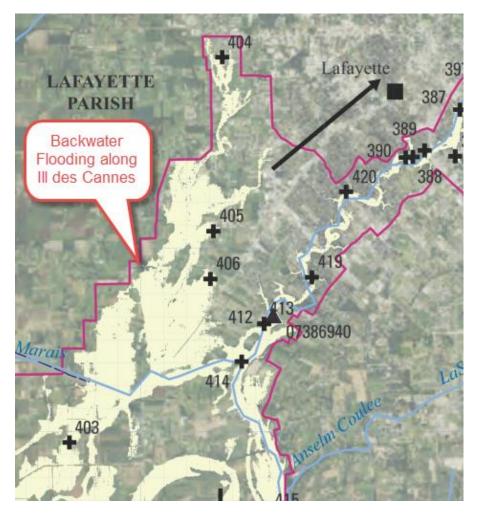
Areas adjacent to the coulee experienced significant backwater flooding during the August 2016 event. This is illustrated in the below USGS map published after their high-water mark survey of the 2016 event.

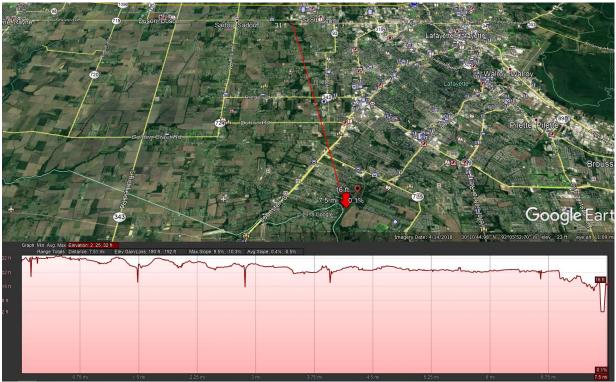
# Elevation Profile III des Cannes

The above is an elevation profile that exhibits the top bank elevations from near the coulee's head waters near 110 west of Scott to where the coulee enters the river north of Maurice. The approximate elevation change north-south is about 15 ft.

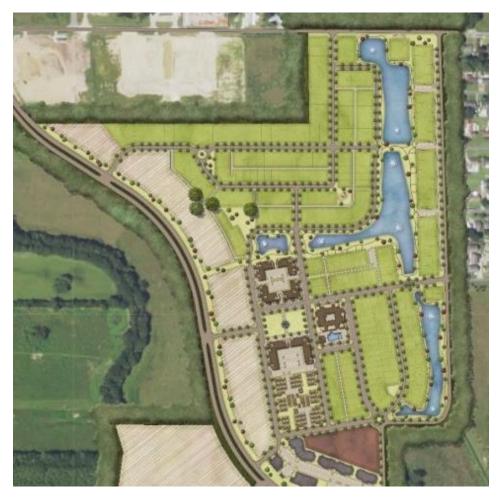
Conceptual Diagram of the West Village Development

However, there is a large pile of spoil near a 143 acre mixed use subdivision development West Village by Cottage Developers adjacent to the Apollo Road extension which shows some retention for the development. See below conceptual diagram of the development.

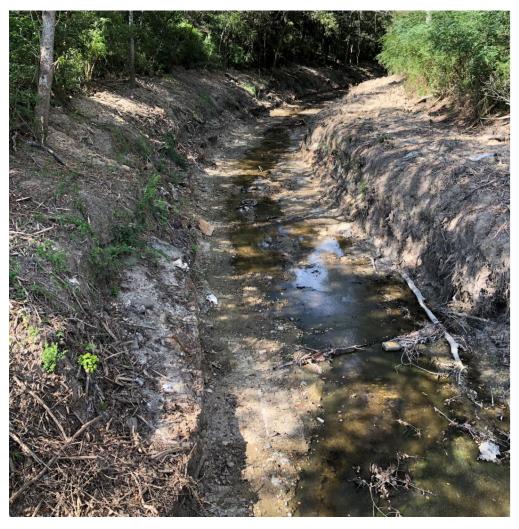
Ill Des Cannes prior to Channel Improvements (North of Old Spanish Trail)

The original channel north of Old Spanish Trail was approximately 25 ft wide at top 15 ft at bottom and about 6 ft deep from top bank.

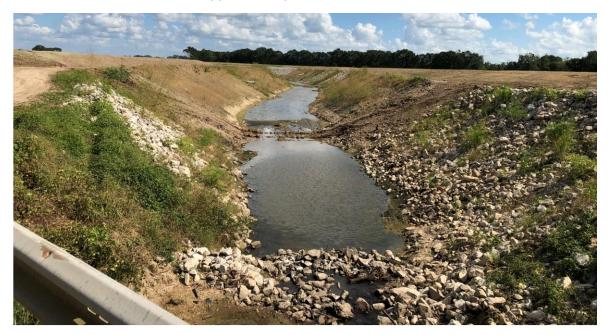
Ill Des Cannes after to Channel Improvements (South of Old Spanish Trail)

The new channel is approximately 90-100 wide at top 25-30 feet at bottom and about 15ft deep from top bank. We were able to measure from a bridge 16.5ft from bridge deck to bottom of coulee. This is a channel size increase of approximately 780%

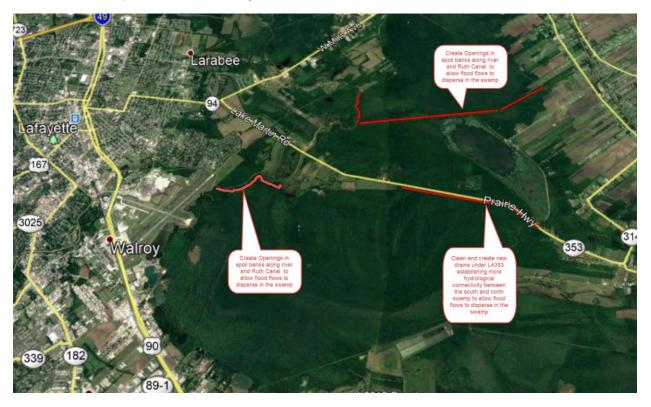
In addition to detention-retention on the coulees a through survey and investigation of any impediments in moving flood flows from the river into the Cypress Island Swamp and dispersing the flood into the swamp as efficiently as possible. The swamp area has some spoil banks between the river and the swamp and the Ruth Canal and the swamp that potentially restrict flood flows from dispersing into the swamp. These restrictions need further investigation and analysis. A boat survey made on Oct 20 identified several spoil banks but undergrowth and trees obstructed views as well as position of the spoil made it difficult to determine if adequate cuts were left open. Additionally, there appears to be inadequate drains under LA353 inhibiting hydrological communications between the north and south areas of the swamp. See the below image.

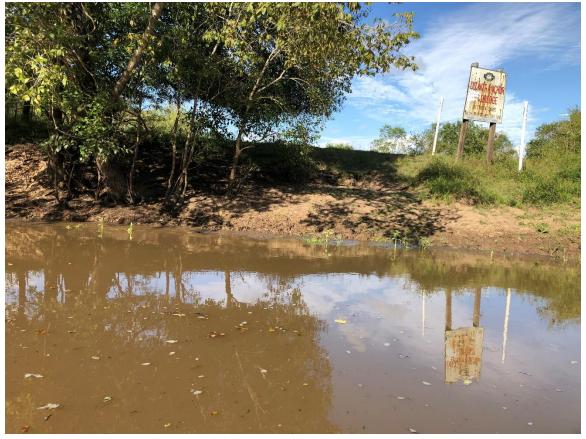
Example Spoil Bank observed at pipeline crossing along river during boat survey made in Oct 2019.
